ADVANCED CERAMIC TURBINE SEAL SYSTEM, PHASES II AND III
FINAL REPORT
PWA-5426

29 NOVEMBER 1976

Contract N00140-74-C-0586

PRATT & WHITNEY AIRCRAFT

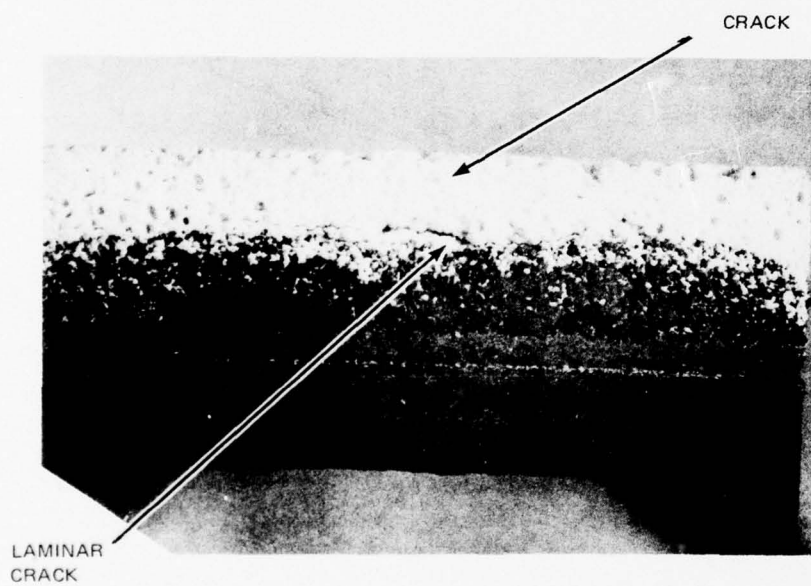
Figure 4 Graded Ceramic-Metal Seal Specimen (Preaged 100 Hours at 1600°F) After 203 Thermal Fatigue Cycles

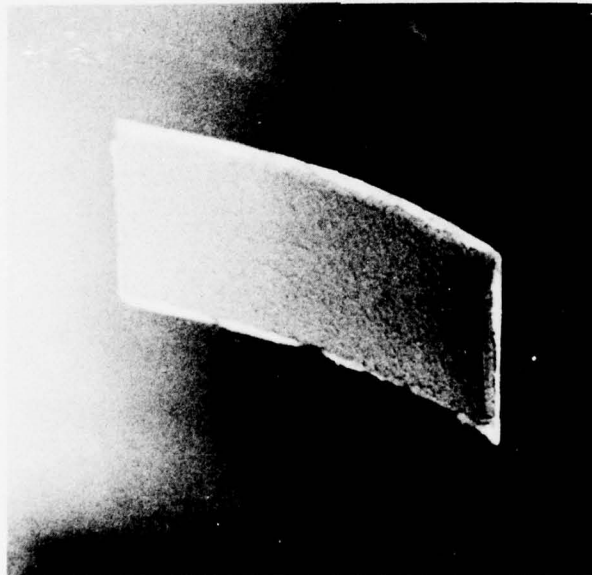
Figure 6 Graded Ceramic-Metal Thermal Fatigue Specimen at 410 Cycle — Idle Condition

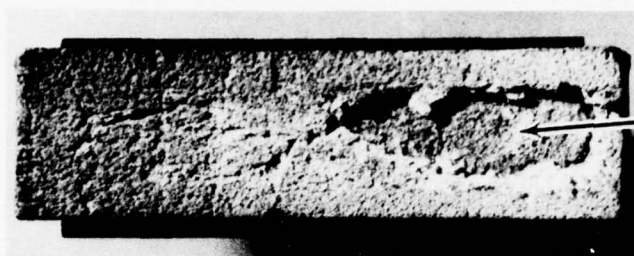
TEST 1
ROOM TEMP.
THERMAL CYCLED

Tests 1 and 2 illustrate the effect of inadequate ZrO_2 -to-intermediate-layer bond, which was not observed in Phase II testing. Tests 3 and 4 depict the effect of ZrO_2 with inferior strength, which also was not experienced in Phase II testing. The defects associated with the four tests are definite fabrication quality problems as noted by nondestructive testing. The quality control problems are discussed in detail on page 15.

CERAMIC COATING
SPALLATION
CERAMIC LAYER SPALLED
AT THE ALL CERAMIC/
GRADED CERAMIC-METAL
INTERFACE

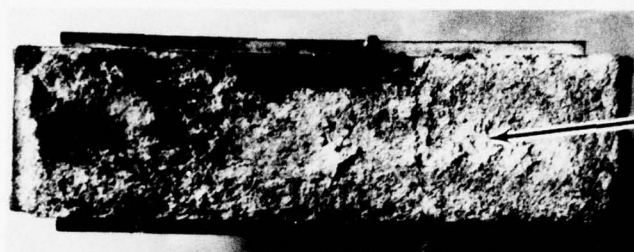
TEST 2
2900° F

CERAMIC COATING
DELAMINATION
COMPLETE DELAMINATION
OF THE ALL-CERAMIC
LAYER

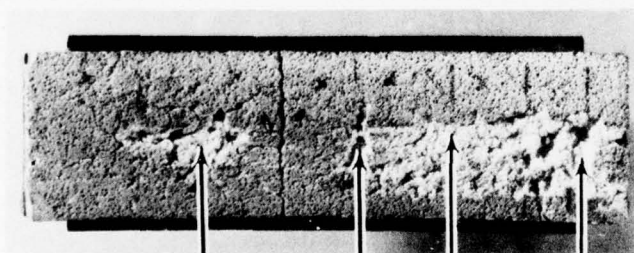
TEST 4
ROOM TEMP.
THERMAL CYCLED

SEAL GROOVING/
SURFACE SPALLATION

0.035-IN.-DEEP
SPALL

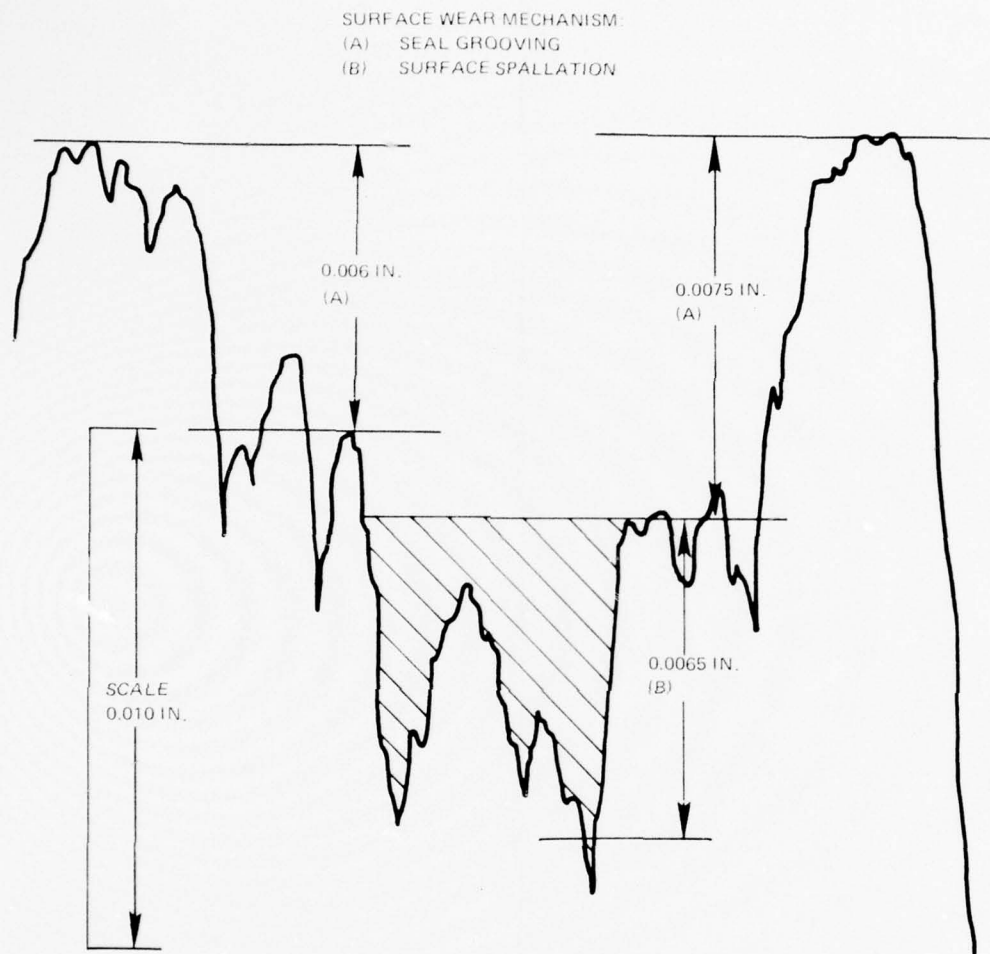
Figure 11 is a profilometer measurement of the rub and spallation surface depth.

Figure 11 Rub Stability — Profile Trace of "Initial" Rub Abradability Test Specimen No. 3

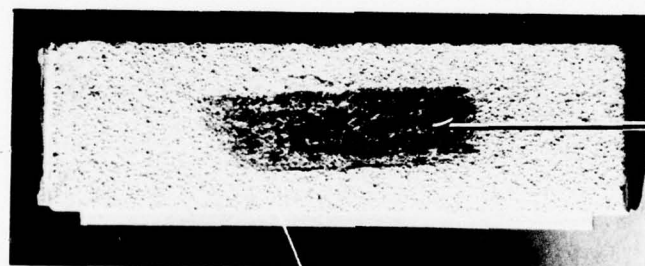
TEST 3
ROOM TEMP.

SEAL GROOVING
WITH SUBSEQUENT
BLADE TIP TRANSFER

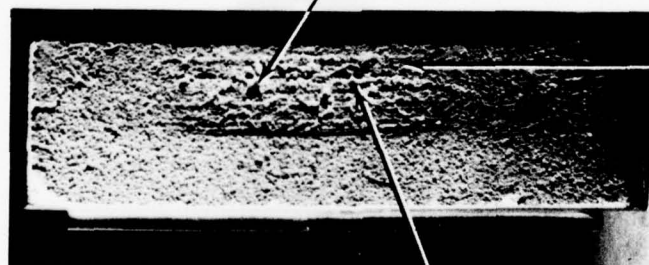
TEST 4
ROOM TEMP.
THERMAL CYCLED

MAXIMUM SPALL
~ 0.016 INCHES BELOW
GROOVE AT ISOLATED
LOCATIONS

SEAL GROOVING
SURFACE SPALLATION

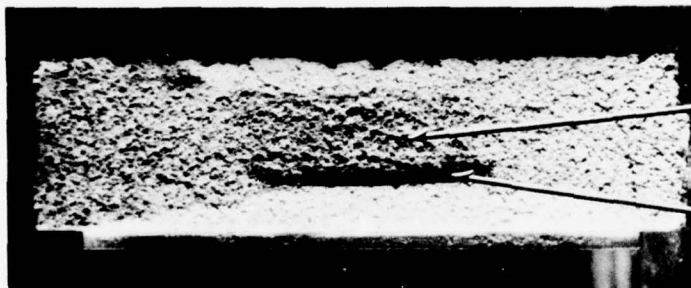
TEST 3 AT
ADVANCED ENGINE
CYCLE TEMPERATURE

SEAL WEAR WITH
NO BLADE TRANSFER

LOCALIZED BLADE TIP
HEATING CAUSING
SUBSEQUENT TRANSFER

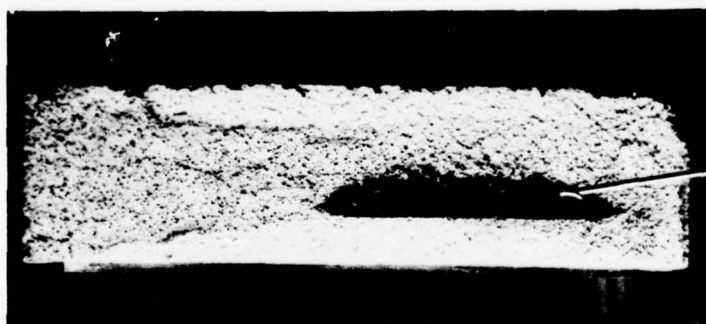
TEST 4 AT
ADVANCED ENGINE
CYCLE TEMPERATURE

SEAL GROOVING
WITH SUBSEQUENT
BLADE TIP TRANSFER

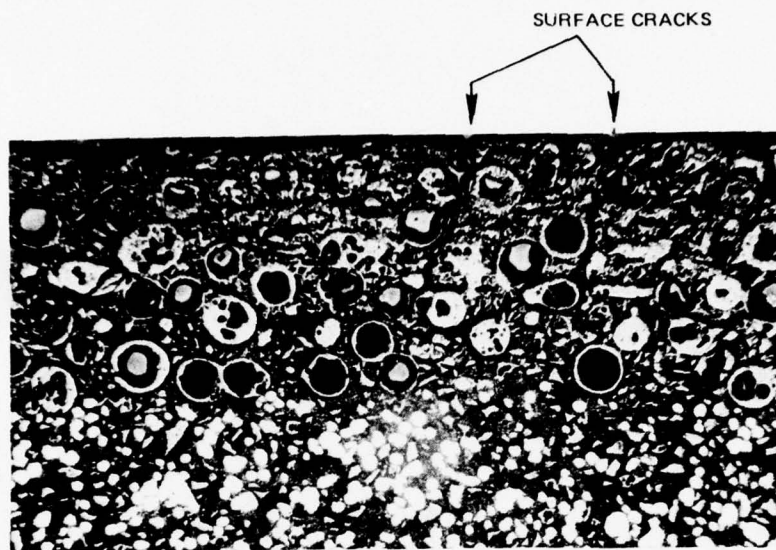
Figure 5 Cross Section of Hot Gas Erosion Specimen Showing Stable Mud Flat Cracks

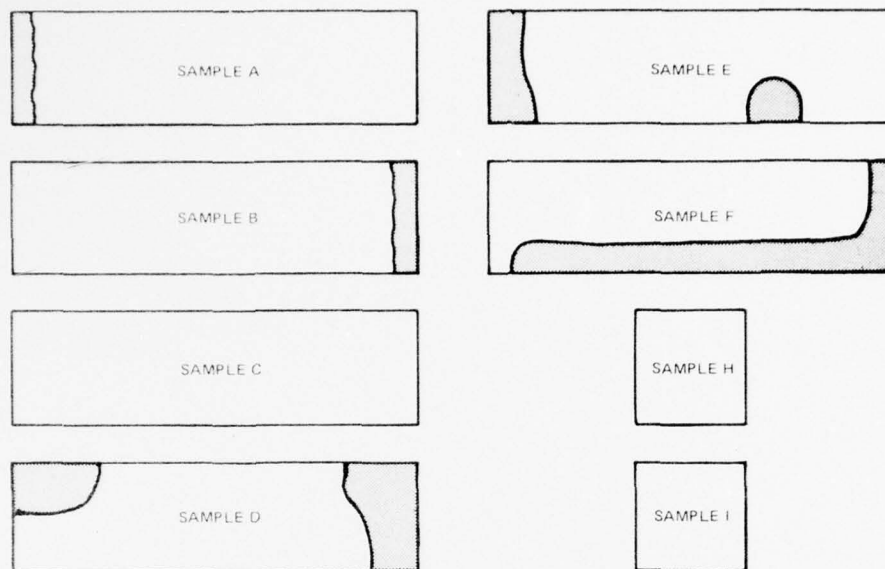
Figure 2 Ultrasonic Indications of Disbond (Shaded Regions) on Seal Test Specimens

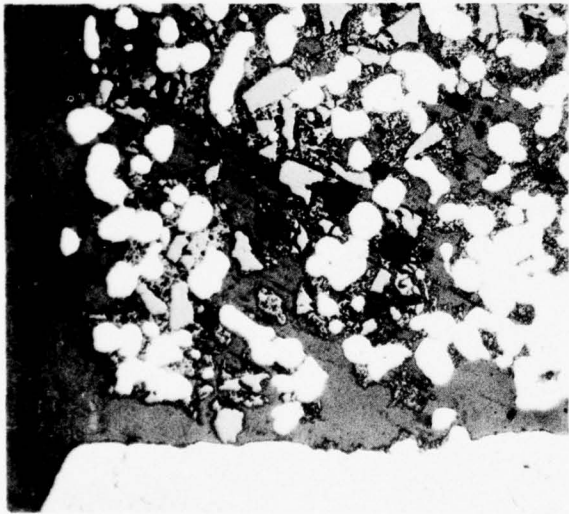
Figure 5 Microstructure at Plane 1b in Seal Sample 1, Verifying the Ultrasonic Inspection Indications of Dishbond at the Interface of the Graded ZrO_2 -NiCr Layer and the Substrate

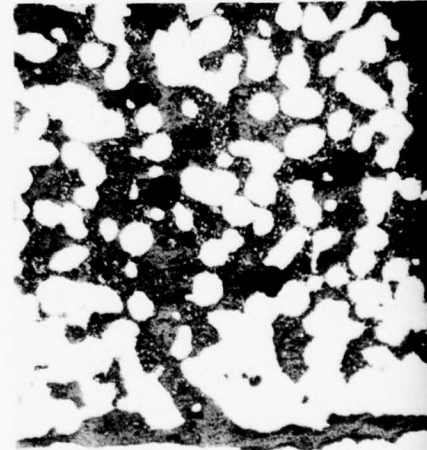
Specimen 2 was sectioned in two areas to verify the ultrasonic disbond indications. Metallurgical examination at planes 2a and 2b clearly showed that the ultrasonic indications are associated with a separation between the graded ceramic-metal system and MAR-M-509 substrate (Figure 6).

Figure 6 Microstructure at Plane 1b in Seal Sample 1, Verifying the Ultrasonic Inspection Indications of Dishbond at the Interface of the Graded ZrO_2 -NiCr Layer and the Substrate
